## Report 2026\_05\_11\_1504

## ***Belt Incline to kiln***

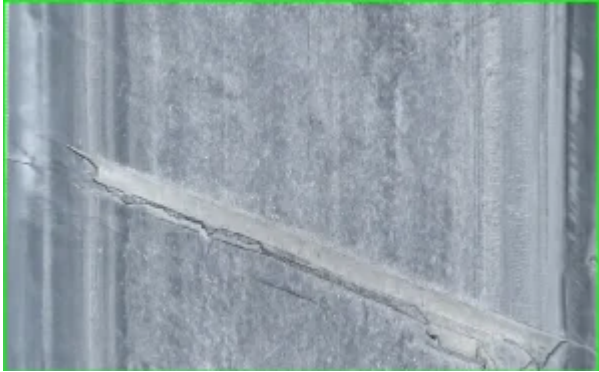
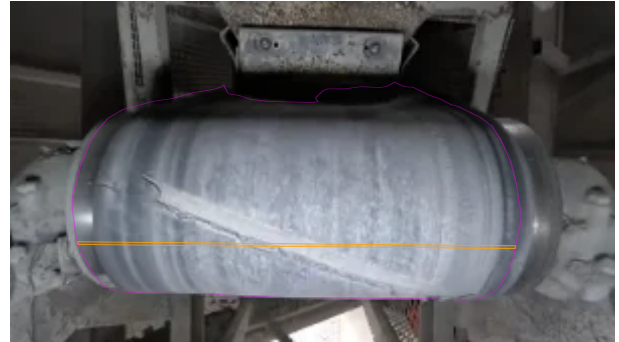
## Splice ID 1

Dimension (width x length): 75cm x 47cm

Position from report start: 0.66 m

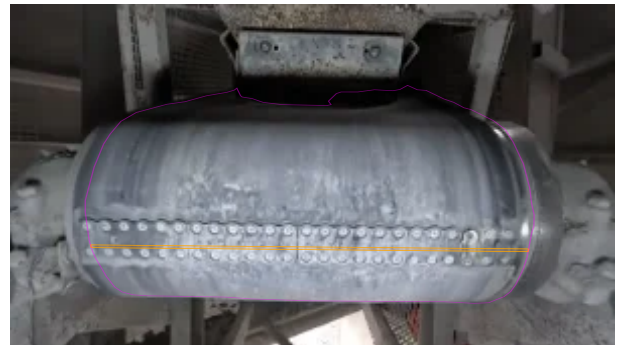
## Splice ID 2

Dimension (width x length): 75cm x 21cm

Position after last connection: 70.48 m

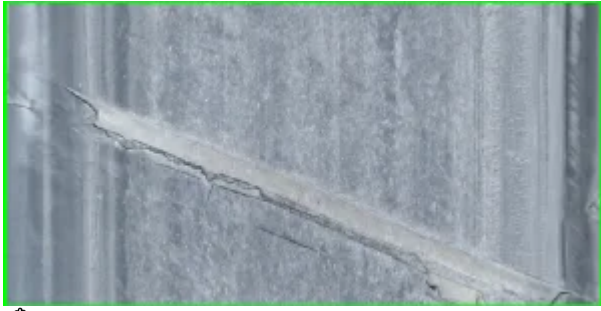
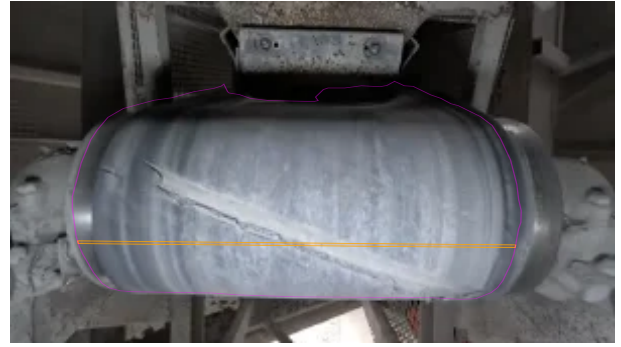
## Splice ID 3

Dimension (width x length): 75cm x 39cm

Position after last connection: 202.21 m

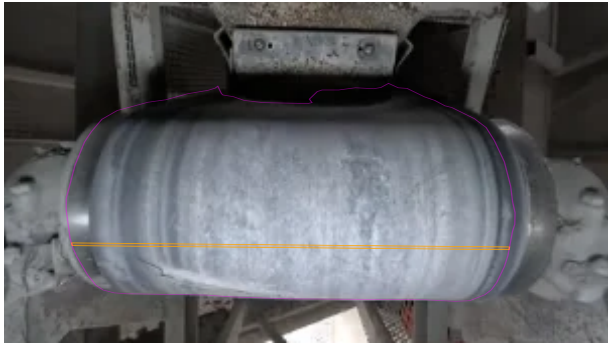
Surface damage ID 1

Dimension (width x length): 4cm x 5cm  
Position from report start: 0.51 m  
Seconds after report start: 0.42 s

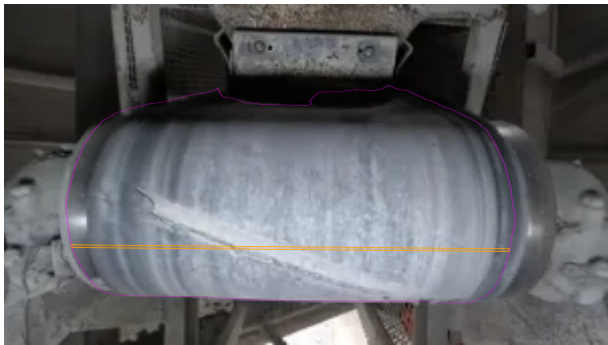
Surface damage ID 2

Dimension (width x length): 6cm x 6cm  
Position from report start: 0.64 m  
Seconds after report start: 0.52 s

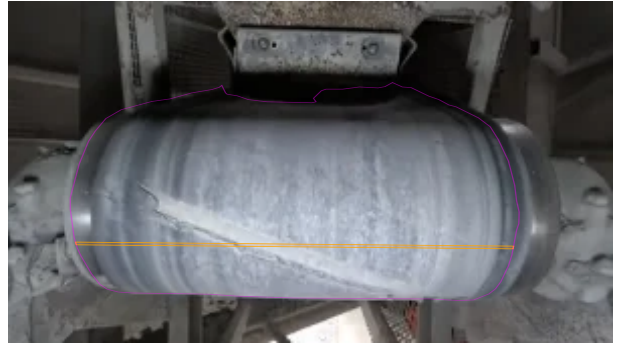
Surface damage ID 3

Dimension (width x length): 4cm x 5cm

Position from report start: 0.64 m

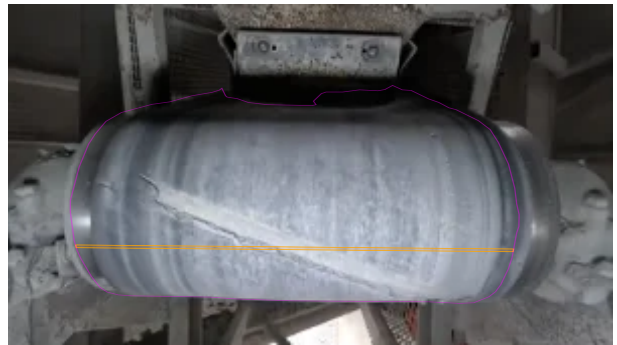
#### Surface damage ID 4

Dimension (width x length): 5cm x 4cm

Position from report start: 0.66 m

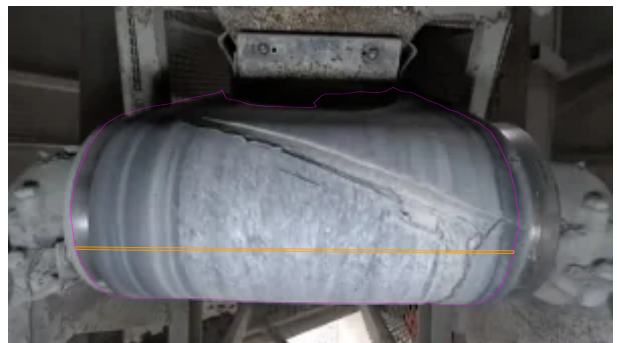
#### Surface damage ID 5

Dimension (width x length): 4cm x 4cm  
Position from report start: 0.84 m  
Seconds after report start: 0.69 s

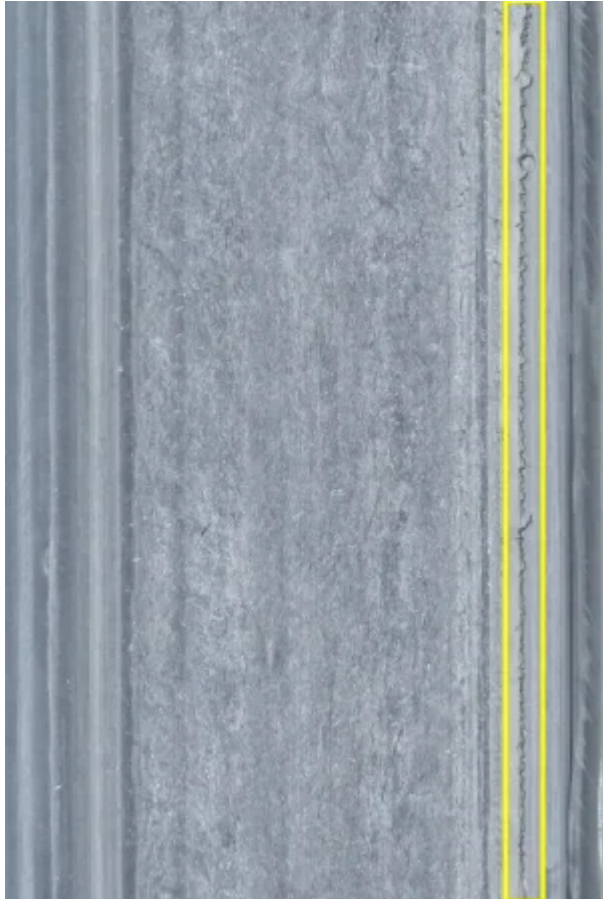
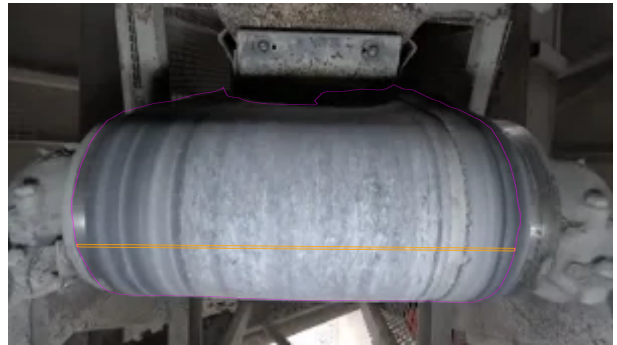
### Surface damage ID 6

Dimension (width x length): 5cm x 113cm  
Position after last connection: 0.52 m  
Seconds since last connection: 0.42 s

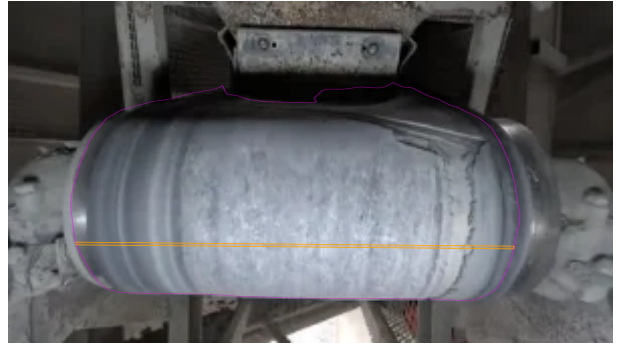
### Surface damage ID 7

Dimension (width x length): 5cm x 7cm  
Position after last connection: 0.52 m  
Seconds since last connection: 0.42 s

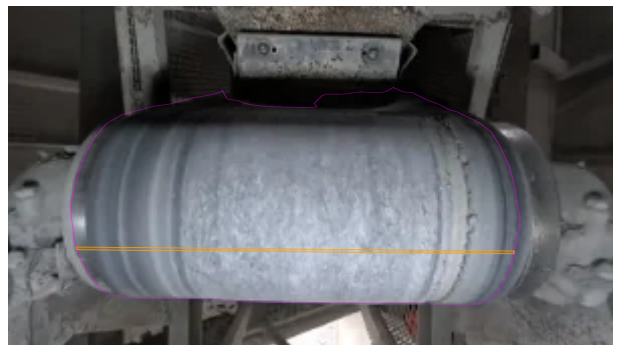
### Surface damage ID 8

Dimension (width x length): 5cm x 4cm  
Position after last connection: 0.70 m  
Seconds since last connection: 0.57 s

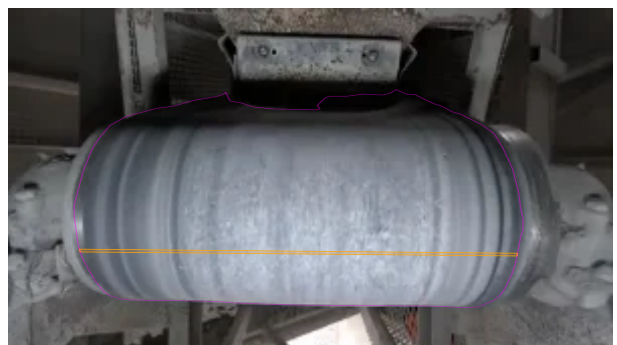
### Surface damage ID 9

Dimension (width x length): 4cm x 17cm  
Position after last connection: 2.29 m  
Seconds since last connection: 1.86 s

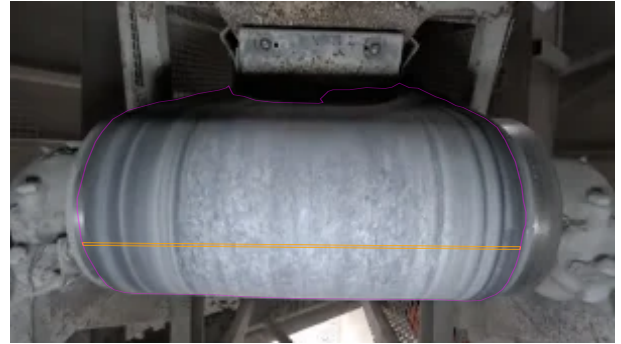
### Surface damage ID 10

Dimension (width x length): 5cm x 8cm  
Position after last connection: 2.81 m  
Seconds since last connection: 2.29 s

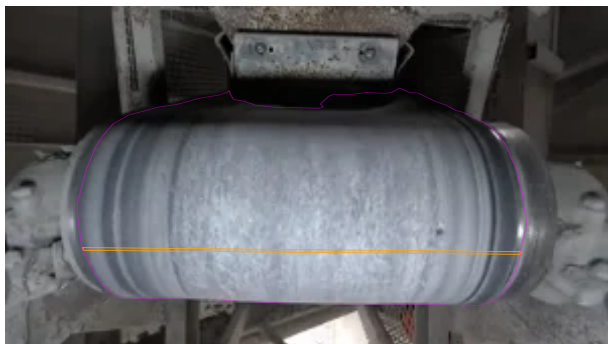
## Edge damage ID 1

Dimension (width x length): 3cm x 19cm  
Length: 189.7 mm  
Position after last connection: 9.47 m  
Seconds since last connection: 7.70 s

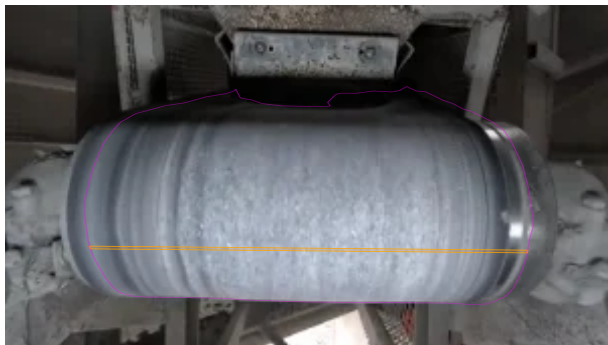
## Edge damage ID 2

Dimension (width x length): 4cm x 5cm  
Length: 47.6 mm  
Position after last connection: 60.43 m  
Seconds since last connection: 49.13 s

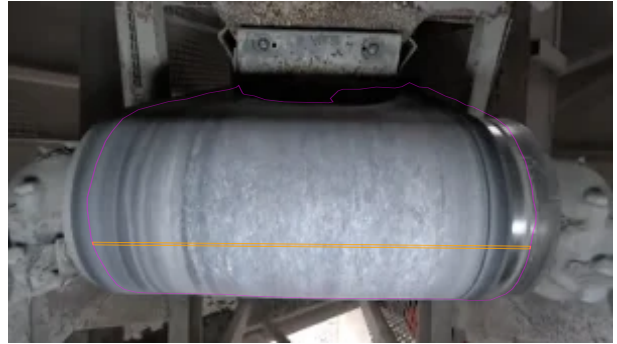
## Edge damage ID 3

Dimension (width x length): 3cm x 17cm  
Length: 169.4 mm  
Position after last connection: 67.37 m  
Seconds since last connection: 54.77 s

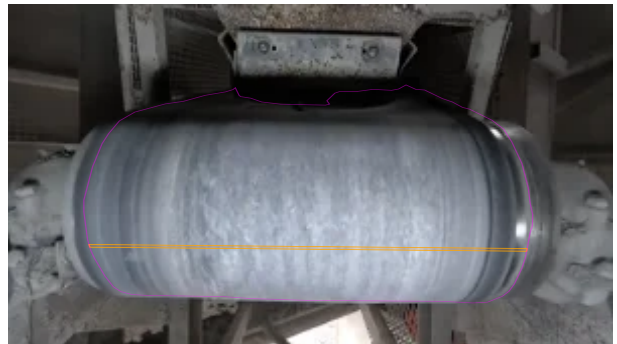
#### Edge damage ID 4

Dimension (width x length): 2cm x 4cm  
Length: 35.9 mm  
Position after last connection: 70.23 m  
Seconds since last connection: 57.10 s

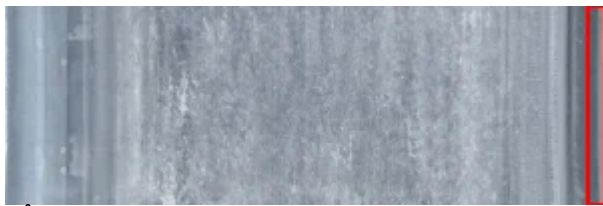
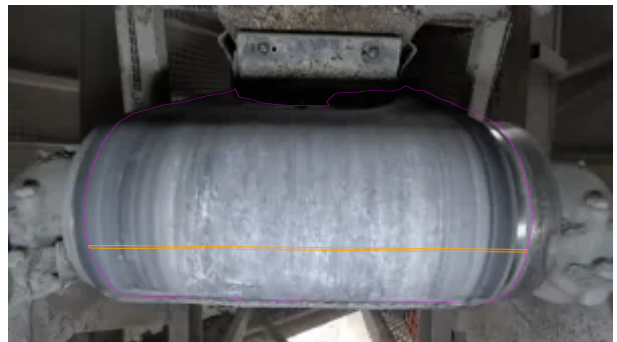
#### Edge damage ID 5

Dimension (width x length): 3cm x 25cm  
Length: 248.3 mm  
Position after last connection: 70.29 m  
Seconds since last connection: 57.15 s

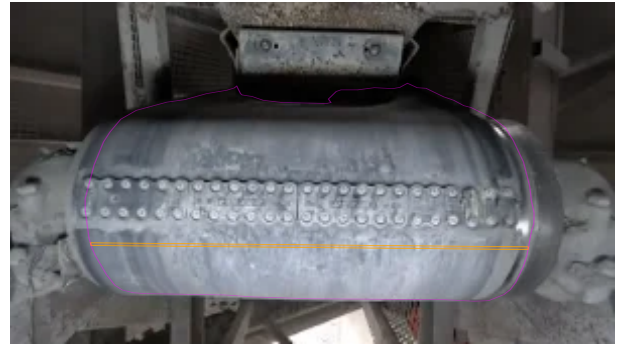
#### Edge damage ID 6

Dimension (width x length): 6cm x 15cm  
Length: 142.1 mm  
Position after last connection: 70.58 m  
Seconds since last connection: 57.38 s

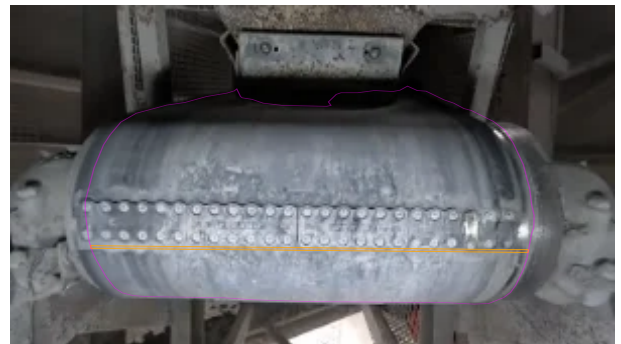
#### Edge damage ID 7

Dimension (width x length): 4cm x 4cm  
Length: 37.3 mm  
Position after last connection: 70.60 m  
Seconds since last connection: 57.40 s

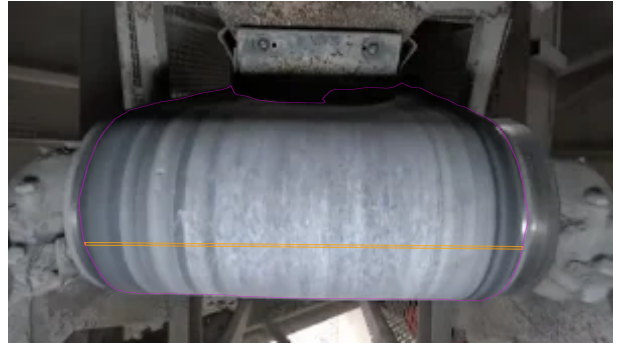
#### Edge damage ID 8

Dimension (width x length): 2cm x 6cm  
Length: 57.8 mm  
Position after last connection: 33.53 m  
Seconds since last connection: 27.26 s

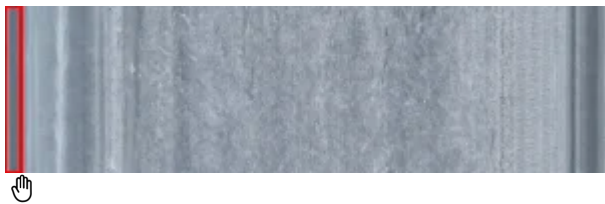
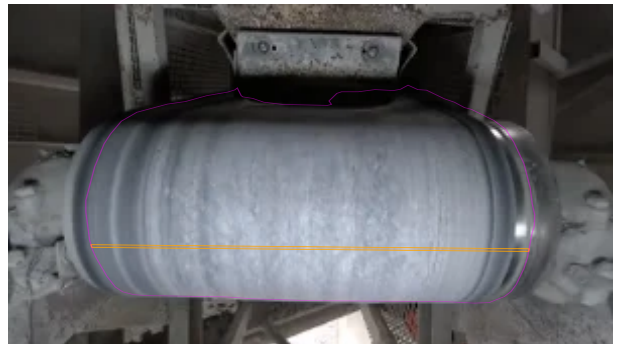
### Edge damage ID 9

Dimension (width x length): 3cm x 21cm  
Length: 208.1 mm  
Position after last connection: 115.17 m  
Seconds since last connection: 93.64 s

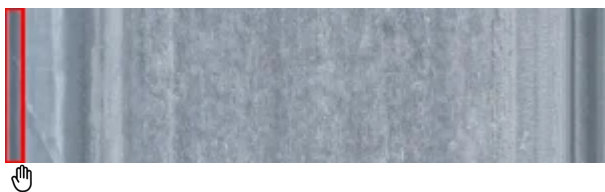
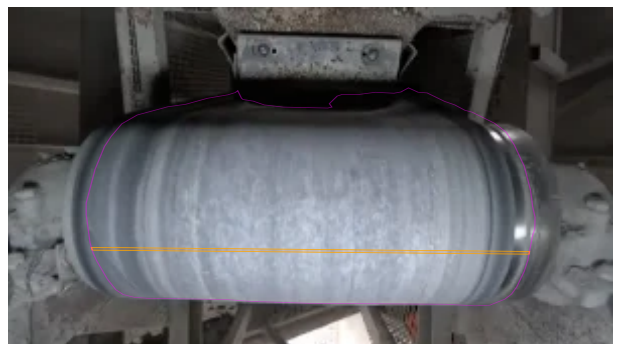
### Edge damage ID 10

Dimension (width x length): 3cm x 20cm

Length: 192.6 mm

Position after last connection: 120.52 m
